Technical expertise on the cause of engine failure of the Mitsubishi Pajero Sport

Ján Mandelík¹

ABSTRACT: *The article concerns the case of the damage to the Mitsubishi Pajero Sport engine and the methodology a technical expert applied to identify a direct cause of failure. The engine failure occurred while a vehicle was being repaired to eliminate air conditioning malfunction and engine overheating. When repairing, it was necessary to replace a cylinder head and the pistons were checked removing the pulley from a crank shaft. After the repair had been completed and after 16-day vehicle operation, engine timing belts got damaged. To eliminate this malfunction, damaged belts were replaced. Thirty (30) days after the vehicle had been put into operation, emergency engine failure occurred, and a technical expert was called upon to assess the quality of the repairs having been performed. The article describes the procedures and methodology a technical expert applied. In the conclusion, the findings are stated. To determine the cause, a vehicle was on the car service station premises, where a technical expert was present and according to his instructions, diagnostic and subsequent disa

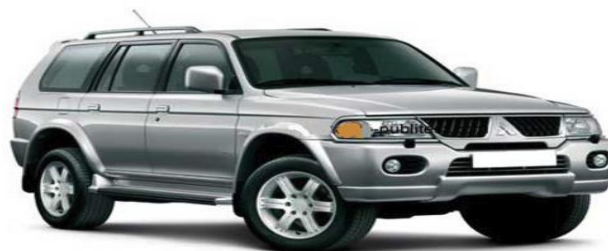
Figure 1: View of the Mitsubishi Pajero Sport

Make: Mitsubishi Pajero Sport
Mileage: 133 000 km
Mileage after the first repair: 2 300 km
View of a vehicle is shown in Fig. 1.

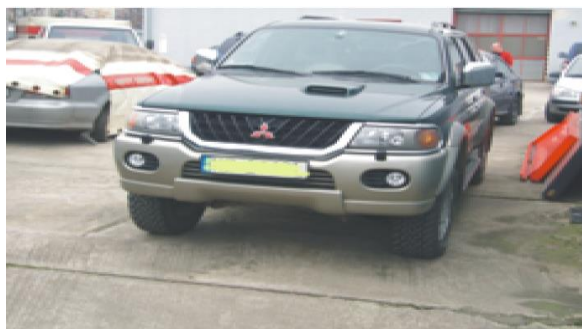
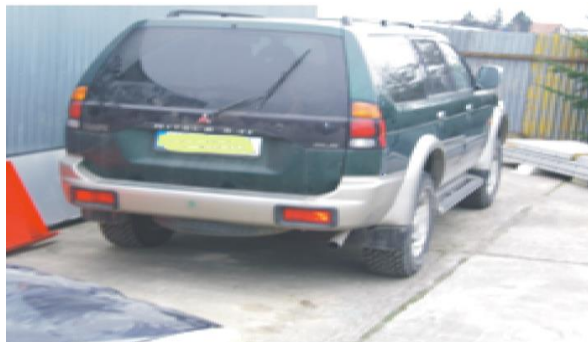
Vehicle

The photographs taken upon the inspection of the vehicle and the vehicle engine, and the description of individual parts are in Fig. 2.

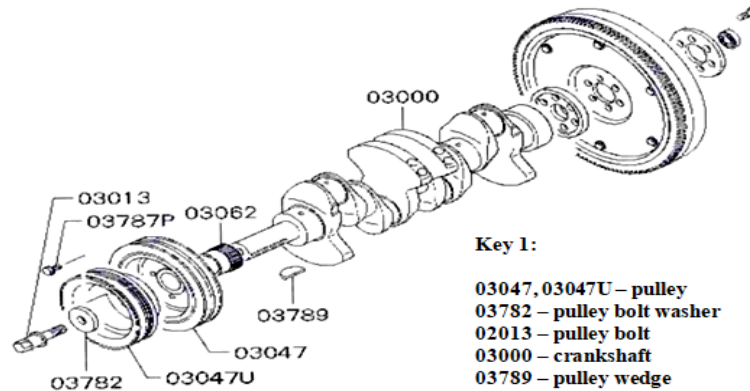
Figure 3: The relative positions of the pulley, pulley bolt washer, pulley bolt and pulley wedge

pulley – the internal part of the surface is significantly damaged within the reach of the wedge, traces of excessive turns compared with the position secured by a wedge- Fig.3

Damage to the above-mentioned parts can occur mainly by loosening the bolt of the crankshaft pulley, because of it not being fastened and gradually loosened.

Possible cause of failure: There are typical, obvious signs of the damage due to an unfastened pulley bolt on a crankshaft during assembly process. The said bolt got gradually loosened due to the rotation of the crankshaft, and consequently:

The cause of the described technical condition was the loosened crankshaft pulley, the movement of which was related to the changed position and angle to the crankshaft. The extent and the nature of damage correspond with the time of operation from the repairs completed on 18 October 2006, after which the vehicle was in service for 2, 300 km (133, 000 – 127, 700).

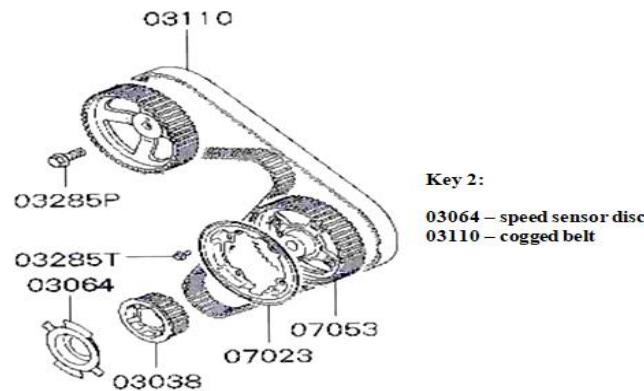
Figure 4: The relative position of speed sensor disc and cogged belt.

The speed sensor disc, whose rotation is sensed by an engine speed sensor.
